Irrigation IOT User Manual

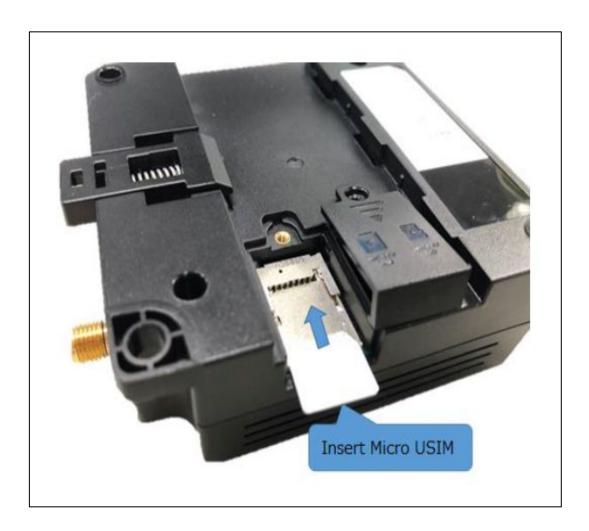
The SIM card is pre-installed in the Micro card slot at the factory. However, the SIM card can be accessed if necessary. The Micro card slot is protected by the cover and can be removed by removing the screw holding the cover. The SIM card must be programmed to work with the CPTrans. Hitachi typically handles this programming, but customers can also program if needed.
